Home Inspection Report

20420 SW 22nd Ave, Portland, OR 97219

Wednesday, January 20, 2016

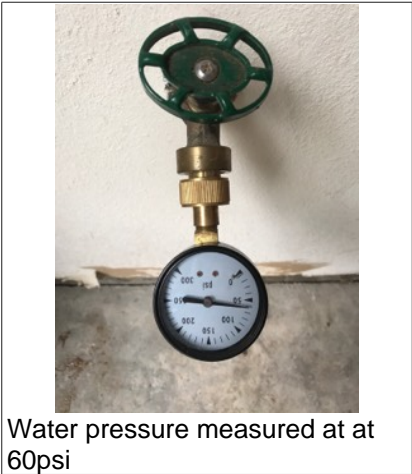
Water pressure measured at 60psi

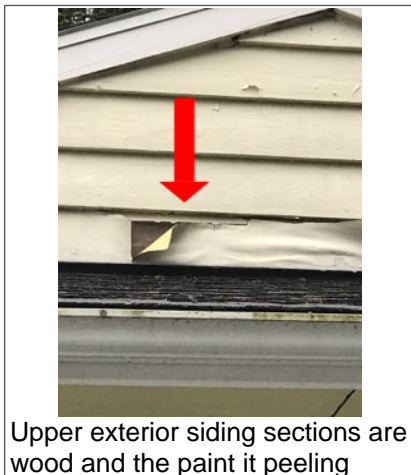
Condition ☐ Satisfactory ☒ Marginal ☐ Poor ☒ Recommend repair/painting

Comments -Upper area section of siding above garage is wood with peeling paint

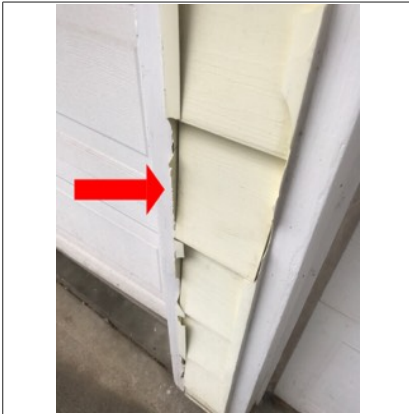
Comments -Multiple locations of exterior vinyl trim is chipped and broken

Multiple locations of exterior vinyl trim is chipped and broken

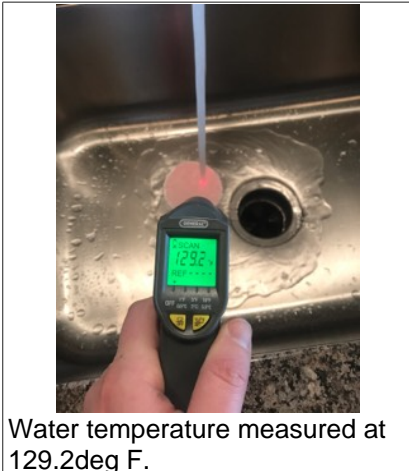
Comments Water temperature measured at 129.9deg F.

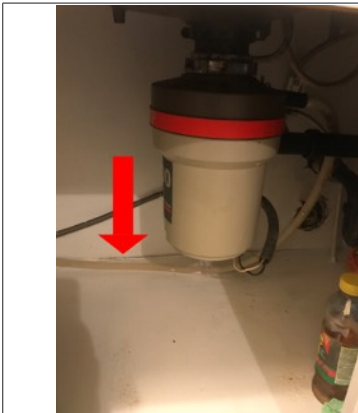
Comments -Dishwasher drain line is not looped above the underside of kitchen sink, this is a cross connecting safety hazard
 -Kitchen electrical receptacle near sink is not GFCI
 This is a safety hazard

Dishwasher drain is not looped above underside of kitchen sink

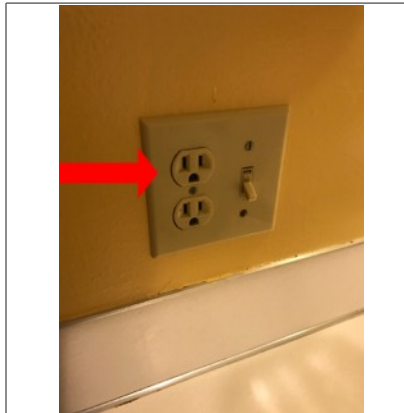
Kitchen electrical receptacle is not GFCI

GFCI ☐ Yes ☒ No Operable: ☐ Yes ☒ No Recommend GFCI Receptacles: ☒ Yes ☐ No

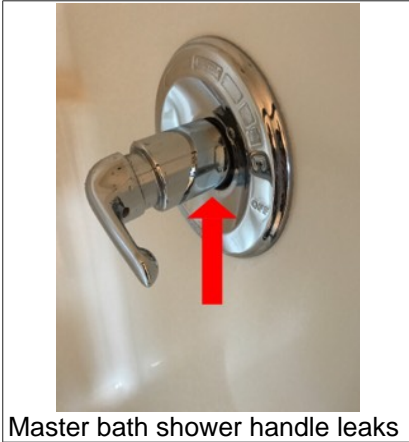
Sinks Faucet leaks: ☐ Yes ☒ No Pipes leak: ☐ Yes ☒ No
Showers ☐ N/A Faucet leaks: ☒ Yes ☐ No Pipes leak: ☐ Yes ☐ No ☒ Not Visible
Drainage ☒ Satisfactory ☐ Marginal ☐ Poor
Water flow ☒ Satisfactory ☐ Marginal ☐ Poor
Moisture stains present ☐ Yes ☒ No ☐ Walls ☐ Ceilings ☐ Cabinetry
Doors ☒ Satisfactory ☐ Marginal ☐ Poor
Window ☐ None ☒ Satisfactory ☐ Marginal ☐ Poor
Receptacles present ☒ Yes ☐ No Operable: ☒ Yes ☐ No
GFCI ☒ Yes ☐ No Operable: ☒ Yes ☐ No ☐ Recommend GFCI
Open ground/Reverse polarity ☐ Yes ☒ No ☐ Potential Safety Hazard
Heat source present ☒ Yes ☐ No
Exhaust fan ☒ Yes ☐ No Operable: ☒ Yes ☐ No ☐ Noisy
Comments -Master bathroom shower faucet handle leaks

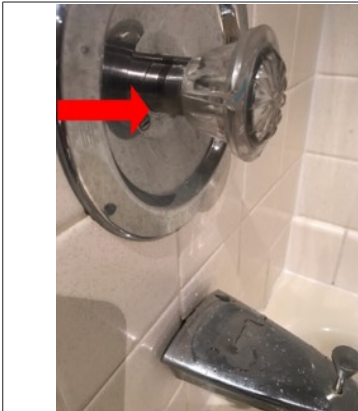
Comments -Hallway tub faucet handle leaks
 -Hallway toilet is loose at floor

Hallway bathtub faucet handle leaks

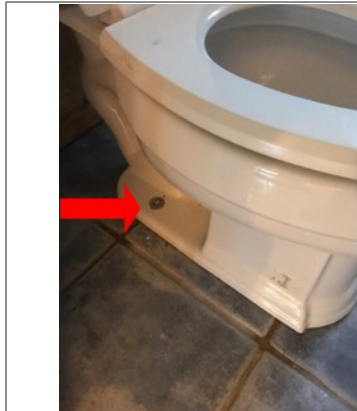
Toilet Bowl loose: ☒ Yes ☐ No Operable: ☒ Yes ☐ No ☐ Cracked bowl ☐ Toilet leaks

Hallway toilet is loose at floor

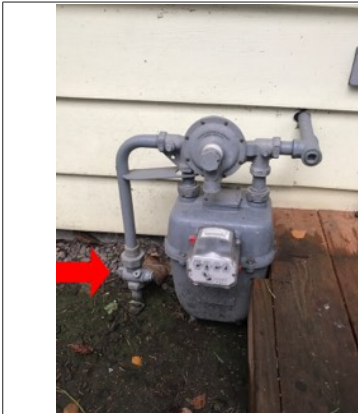
Main fuel shut off located on east side of exterior

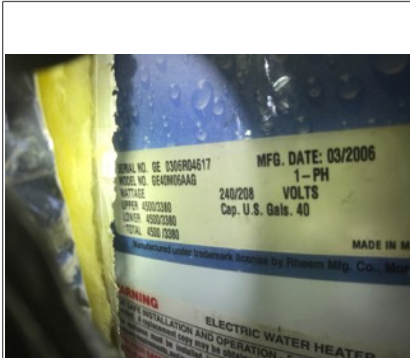
Water heater label

- Water heater manufactured March 2006, approximately 10 years old. Typical life of a water heater is 8-12 years. This water heater still produced hot water

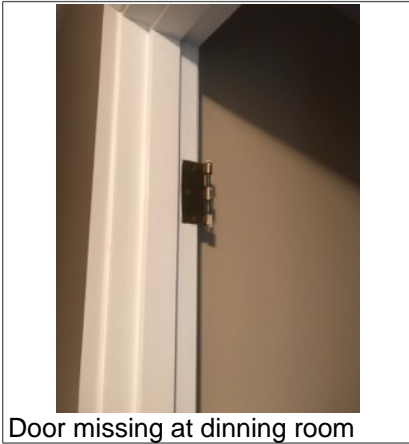
Comments -Door missing at dinning room

Door missing at dinning room
